WESTWOOD RECREATION GROUND
SECTION 19 FLOOD INVESTIGATION

PREPARED FOR THE LONDON BOROUGH OF REDBRIDGE

Authored by Ella Walsh
Reviewed by: Emma Rowlands
Approved by Mike Mair
Date October 2023
Version 2.0

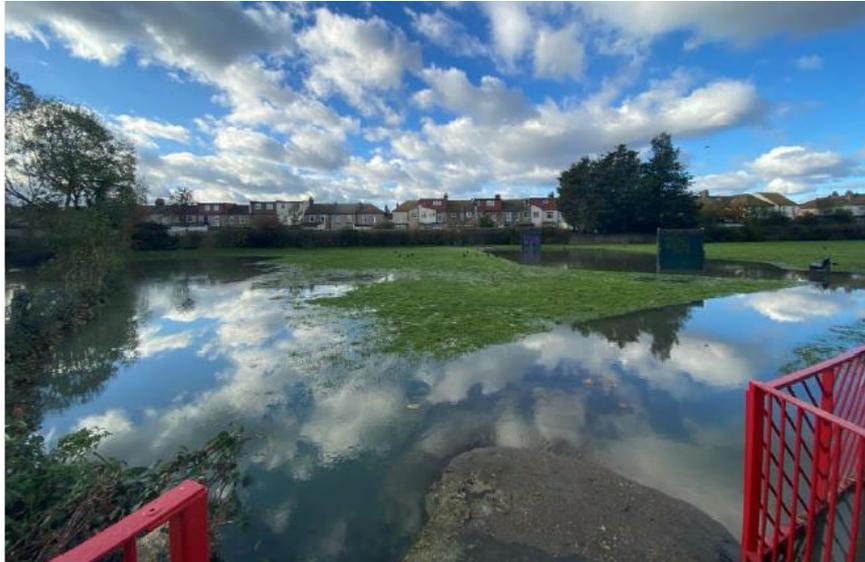
This heavy rainfall caused significant flooding to Westwood Recreation Ground and the surrounding properties. Seven Kings Water overtopped its banks on both sides, covering the pathway to the east of the watercourse and extending towards the houses bordering the western side of the park. There

was also flooding in the south-western section of the park, beyond where the stream is culverted. *Figure 3-2* and *Figure 3-3* show the flooding in the park as of 13:00 on the 18th of November.

Figure 3-2 Flooding north of the culvert looking towards Chester Road. Source: EA

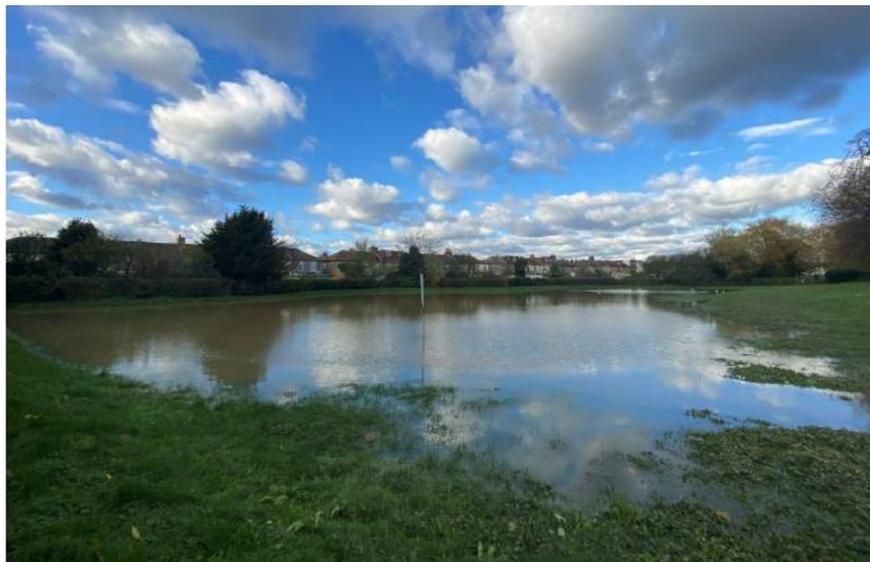
Figure 3-3 Flooding downstream from the trash screen, looking towards Chester Road. Source: EA
