Fire Risk Assessment:

212 - 279 Sunset Court
Navestock Crescent
Woodford
IG8 7BE

1 FIRE RISK ASSESSMENT, 212 - 279 SUNSET COURT

1.1 212 - 279 SUNSET COURT MAIN BUILDING

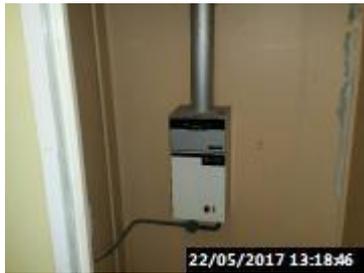
Other sources of ignition	10th floor:Incinerator cupboard	Action plan #
---------------------------	---------------------------------	---------------

Observation:
A very dated sanitary incinerator system is present within the building. The assessor was unable to confirm whether the system has been disconnected from any power supply.

<p>Incinerator cupboard</p> <p>Observation</p> <p>A very dated sanitary incinerator system is present within the building. The assessor was unable to confirm whether the system has been disconnected from any power supply.</p> <p>Recommendation</p> <p>The sanitary incinerator system should be confirmed as disconnected and no longer in use.</p>	<p>Risk score: 9</p>

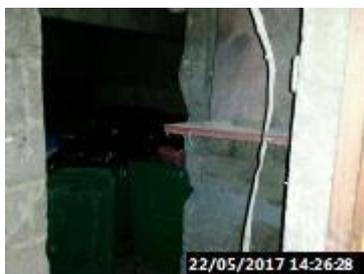
Measures to limit fire spread and development	Ground:Bin room	Action plan #
---	-----------------	---------------

Observation:
There were no fire dampers identified as being fitted to protect against the passage of fire, smoke and combustion through walls, floor, partitions and ductwork. The disused bin chute should either be removed and the duct sealed with a suitable fire resistant material or have appropriate dampers fitted.

<p>Bin room</p> <p>Observation</p> <p>There were no fire dampers identified as being fitted to protect against the passage of fire, smoke and combustion through walls, floor, partitions and ductwork. The disused bin chute should either be removed and the duct sealed with a suitable fire resistant material or have appropriate dampers fitted.</p> <p>Recommendation</p> <p>Investigate whether dampers need to be fitted to protect against passage of fire, smoke and combustion through walls, floor, partitions and ductwork.</p>	<p>Risk score: 9</p>

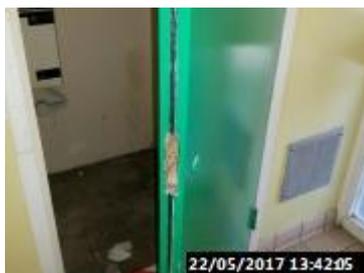
Measures to limit fire spread and development	2nd Floor:Disused incinerator cupboard	Action plan #
---	--	---------------

Observation:
There appeared to be damage to the door. If the integrity of the door is compromised, this could allow the passage of smoke and fire into adjacent areas, which could compromise the means of escape. The missing door lock could also encourage the unauthorised use of this cupboard for storage purposes.

<p>Disused incinerator cupboard</p> <p>Observation</p> <p>There appeared to be damage to the door. If the integrity of the door is compromised, this could allow the passage of smoke and fire into adjacent areas, which could compromise the means of escape. The missing door lock could also encourage the unauthorised use of this cupboard for storage purposes.</p> <p>Recommendation</p> <p>Consideration should be given to repairing or replacing the damaged fire door to ensure full compartmentation. Any works to fire doors should be undertaken by an approved fire door company or a competent person and all materials used should comply with the current specifications.</p>	<p>Risk score: 9</p>

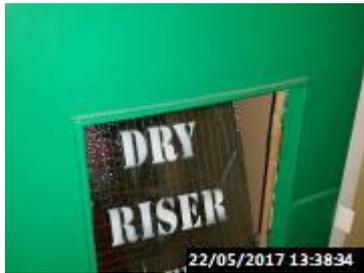
Measures to limit fire spread and development	3rd Floor:Dry riser	Action plan #
---	---------------------	---------------

Observation:
 There appeared to be damage to the door. If the integrity of the door is compromised, this could allow the passage of smoke and fire into adjacent areas, which could compromise the means of escape. The glass panel to the riser cupboard door has been smashed out of place.

<p>Dry riser</p> <p>Observation There appeared to be damage to the door. If the integrity of the door is compromised, this could allow the passage of smoke and fire into adjacent areas, which could compromise the means of escape. The glass panel to the riser cupboard door has been smashed out of place.</p> <p>Recommendation Consideration should be given to repairing or replacing the damaged fire door to ensure full compartmentation. Any works to fire doors should be undertaken by an approved fire door company or a competent person and all materials used should comply with the current specifications.</p>	<p>Risk score: 9</p>

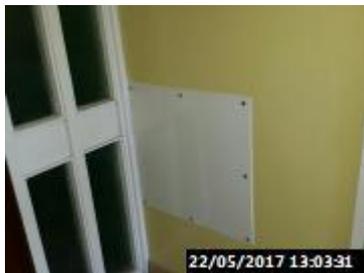
Measures to limit fire spread and development	11th floor:Bin chute lobby	Action plan #
---	----------------------------	---------------

Observation:
 Bin chutes within the building have been withdrawn from use. It is not clear whether the plastic material which has been used to seal up the shaft at all floors is suitably fire resistant. The lobby is on a means of escape route.

<p>Bin chute lobby</p> <p>Observation Bin chutes within the building have been withdrawn from use. It is not clear whether the plastic material which has been used to seal up the shaft at all floors is suitably fire resistant. The lobby is on a means of escape route.</p> <p>Recommendation The material used to seal the bin chutes throughout the building should be confirmed as suitably fire resistant and replaced if found not to be.</p>	<p>Risk score: 9</p>

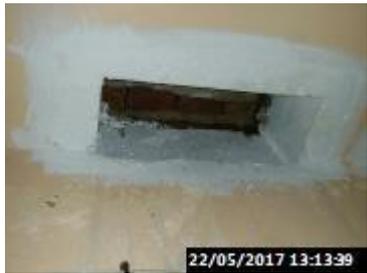
Measures to limit fire spread and development	11th floor:Disused electrical meter cupboards	Action plan #

<p>22/05/2017 13:13:39</p>	<p>Observation: The removal of existing electrical installations has led to potential holes through compartment walls without adequate fire stopping being in place, causing a possible airflow or fire route through compartment walls or structures. This is a non-intrusive inspection and a breach in compartmentation cannot be definitely confirmed, however evidence from other identical blocks of flats on the estate would suggest that fire stopping is required.</p>	<p>4931F0021</p> <p>Risk score: 9</p> <p>Medium</p>
Measures to limit fire spread and development	10th floor:Flats lobby	Action plan #

<p>Disused electrical meter cupboards</p> <p>Observation The removal of existing electrical installations has led to potential holes through compartment walls without adequate fire stopping being in place, causing a possible airflow or fire route through compartment walls or structures. This is a non-intrusive inspection and a breach in compartmentation cannot be definitely confirmed, however evidence from other identical blocks of flats on the estate would suggest that fire stopping is required.</p> <p>Recommendation Fire stopping works should be carried out to certain fire resisting structures. All services penetrating fire resisting walls and ceilings should be fire stopped to the standard of the structure they penetrate.</p>	<p>Risk score: 9</p> <p>Medium</p>

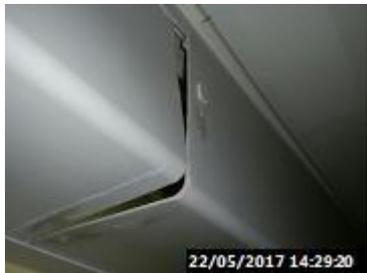
<p>22/05/2017 14:29:20</p>	<p>Observation: It was identified that the linings in place could promote fire spread. A plastic type boxing is evident throughout the building on all floors above the lift entrance doors.</p> <p>Talon boxing removed.</p>	<p>4931F0022</p> <p>Risk score: 9</p> <p>Medium</p>

<p>Flats lobby</p> <p>Observation It was identified that the linings in place could promote fire spread. A plastic type boxing is evident throughout the building on all floors above the lift entrance doors.</p> <p>Recommendation Investigate whether the linings are fire retardent or resistant.</p>	<p>Risk score: 9</p> <p>Medium</p>

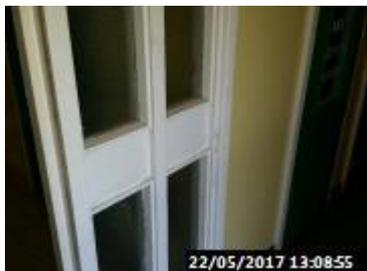
Measures to limit fire spread and development	11th floor:Bin chute lobby	Action plan #

<p>22/05/2017 13:08:55</p>	<p>Observation: There are ventilation grilles on an unknown shaft which runs through all floors of the building between the disused incinerator cupboard and dry riser. There is no manufacturer markings to confirm whether these grilles are suitably fire and smoke resistant.</p>	<p>4931F0023</p> <p>Risk score: 9</p> <p>Medium</p>

<p>Bin chute lobby</p> <p>Observation There are ventilation grilles on an unknown shaft which runs through all floors of the building between the disused incinerator cupboard and dry riser. There is no manufacturer markings to confirm whether these grilles are suitably fire and smoke resistant.</p> <p>Recommendation It should be confirmed whether the grilles are suitably fire and smoke resistant to maintain compartmentation throughout the building and upgraded if required.</p>	<p>Risk score: 9</p>
