# Fire Risk Assessment:

81 - 146 Blenheim Court  
Navestock Crescent  
Woodford  
IG8 7BB

## 1 FIRE RISK ASSESSMENT, 81 - 146 BLENHEIM COURT

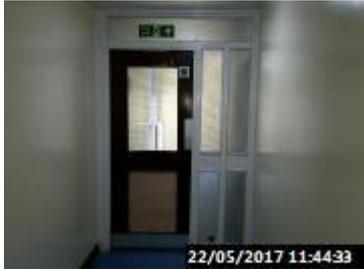
</p>	
Measures to limit fire spread and development	3rd Floor:Flats lobby	Action plan #

<p>22/05/2017 11:44:33</p>	<p><b>Observation:</b> There appeared to be damage to the door. If the integrity of the door is compromised, this could allow the passage of smoke and fire into adjacent areas, which could compromise the means of escape. The fire resisting glazed panel to the lobby door adjacent to flat 95 has been replaced with a timber panel which may not provide adequate protection.</p>	<p>4912F0012 Risk score: 9

<p><b>Flats lobby</b></p> <p><b>Observation</b></p> <p>There appeared to be damage to the door. If the integrity of the door is compromised, this could allow the passage of</p>	<p>Risk score: 9</p>

Action plan #	Category	Description	Priority	Allocated to	Completed by	Current status
		<p>smoke and fire into adjacent areas, which could compromise the means of escape. The fire resisting glazed panel to the lobby door adjacent to flat 95 has been replaced with a timber panel which may not provide adequate protection.</p> <p><b>Recommendation</b></p> <p>Consideration should be given to repairing or replacing the damaged fire door to ensure full compartmentation. Any works to fire doors should be undertaken by an approved fire door company or a competent person and all materials used should comply with the current specifications.</p>				
4912F0013

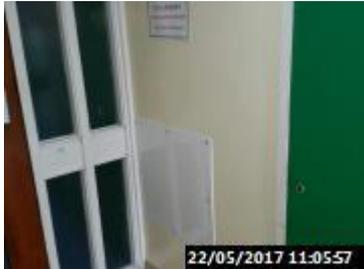
</p>
Measures to limit fire spread and development	11th floor:Formerly bin chute lobby	Action plan #

<p>22/05/2017 11:05:57</p>	<p><b>Observation:</b> The bin chutes at this location have been taken out of service. The assessor is unable to verify whether the plastic type sheet material used to cover the aperture is suitably fire resistant.  <b>Material used is 2mm powder coated steel.</b></p>	<p>4912F0013 Risk score: 9

<p><b>Formerly bin chute lobby</b></p> <p><b>Observation</b></p> <p>The bin chutes at this location have been taken out of service. The assessor is unable to verify whether the plastic type sheet material used to cover the aperture is suitably fire resistant.</p> <p><b>Recommendation</b></p> <p>The fire resistance of the material used to cover the bin chutes should be verified as being suitable to maintain compartmentation for at least 30 minutes.</p>	<p>Risk score: 9</p>

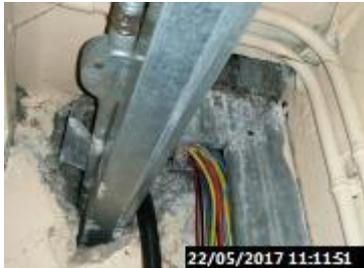
</p>
Measures to limit fire spread and development	11th floor:Electrical riser cupboard	Action plan #

<p>22/05/2017 11:11:51</p>	<p><b>Observation:</b> Pipes, cabling or ductwork was observed to possibly intrude through compartment walls without adequate fire stopping being in place, causing a possible airflow or fire route through compartment walls or structures. The assessor was unable to follow the cable run which appeared to go through to the rear of the lift shaft however no fire stopping appeared to be in place.</p>	<p>4912F0014 Risk score: 9

<p><b>Electrical riser cupboard</b></p> <p><b>Observation</b></p> <p>Pipes, cabling or ductwork was observed to possibly intrude through compartment walls without adequate fire stopping being in place, causing a possible airflow or fire route through compartment walls or structures. The assessor was unable to follow the cable run which appeared to go through to the rear of the lift shaft however no fire stopping appeared to be in place.</p>	<p>Risk score: 9</p>

Action plan #	Category	Description	Priority	Allocated to	Completed by	Current status
		<p><b>Recommendation</b></p> <p>Fire stopping works should be carried out to certain fire resisting structures. All services penetrating fire resisting walls and ceilings should be fire stopped to the standard of the structure they penetrate.</p>				
4912F0015

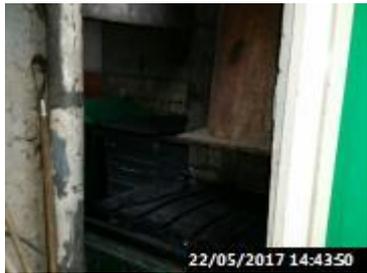
Measures to limit fire spread and development	Ground:Bin store	Action plan #
---	------------------	---------------

**Observation:**  
There were no fire dampers identified as being fitted to the disused bin chute to protect against the passage of fire, smoke and combustion through walls, floor, partitions and ductwork.

4912F0015  
Risk score: 9  
**Medium**

<p><b>Bin store</b></p> <p><b>Observation</b></p> <p>There were no fire dampers identified as being fitted to the disused bin chute to protect against the passage of fire, smoke and combustion through walls, floor, partitions and ductwork.</p> <p><b>Recommendation</b></p> <p>The bin chute should either be permanently sealed with a suitable fire resistant material or have appropriate dampers fitted.</p>	<p>Risk score: 9</p>

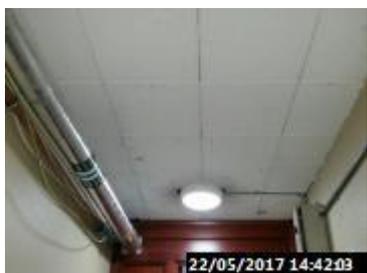
Measures to limit fire spread and development	Ground:Electrical intake, tank room and lobby	Action plan #
---	---	---------------

**Observation:**  
It was identified that the ceiling linings in place were a polystyrene material which could promote fire spread and give off toxic fumes.

4912F0016  
Risk score: 9  
**Medium**

<p><b>Electrical intake, tank room and lobby</b></p> <p><b>Observation</b></p> <p>It was identified that the ceiling linings in place were a polystyrene material which could promote fire spread and give off toxic fumes.</p> <p><b>Recommendation</b></p> <p>Investigate whether the linings are fire retardent or resistant. Consider having them coated for fire resistance or retardency if they do not have a capability.</p>	<p>Risk score: 9</p>

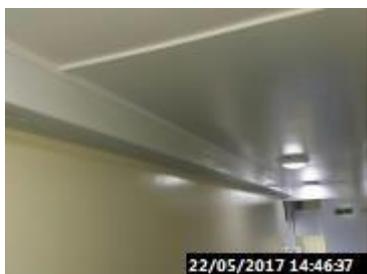
Measures to limit fire spread and development	11th floor:Flats lobby	Action plan #
---	------------------------	---------------

**Observation:**  
It was identified that the linings in place could promote fire spread. A plastic type boxing is evident throughout the building on all floors above flat entrance doors.

4912F0018  
Risk score: 9  
**Medium**

<p><b>Flats lobby</b></p> <p><b>Observation</b> It was identified that the linings in place could promote fire spread. A plastic type boxing is evident throughout the building on all floors above flat entrance doors.</p> <p><b>Recommendation</b> Investigate whether the linings are fire retardant or resistant. Consider having them coated for fire resistance or retardancy if they do not have a capability.</p>	<p>Risk score: 9</p>

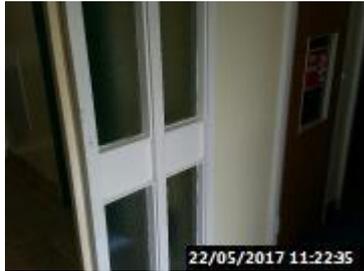
Measures to limit fire spread and development	11th floor: Formerly bin chute lobby	Action plan #
---	--------------------------------------	---------------

**Observation:**  
Ventilation grilles are present on an unknown void which runs through all floors of the building between the disused incinerator cupboard and dry riser. There are no markings to indicate whether these grilles are suitably fire and smoke resistant.

<p><b>Formerly bin chute lobby</b></p> <p><b>Observation</b> Ventilation grilles are present on an unknown void which runs through all floors of the building between the disused incinerator cupboard and dry riser. There are no markings to indicate whether these grilles are suitably fire and smoke resistant.</p> <p><b>Recommendation</b> It should be confirmed that these ventilation grilles are suitable to maintain compartmentation throughout the building as the lobby area forms part of an escape route to the staircase.</p>	<p>Risk score: 9</p>
